## The use of VERSAJET<sup>®</sup> and VISTA to facilitate healing in a grade IV heel ulcer

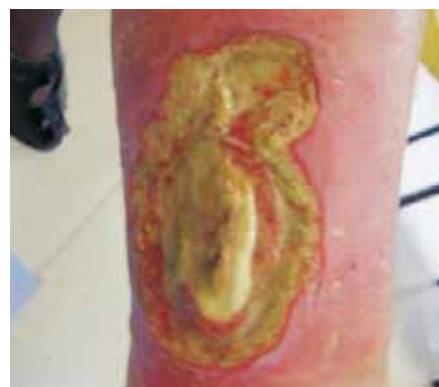
Figure 1 – Mixed aetiology ulcer prior to application of reduced x3 layer elastic compression

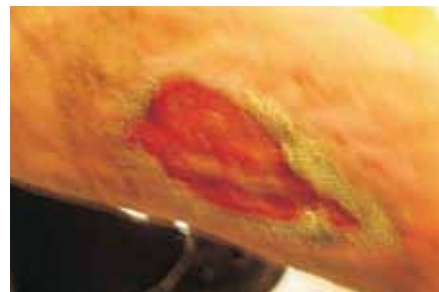
Figure 2 – Mixed Aetiology Leg Ulcer improving with reduced compression

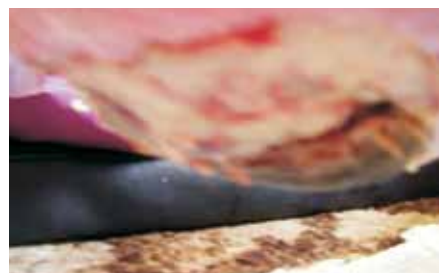
Figure 3 – Grade IV Heel ulcer

Precise debridement was required for the wound as it was covered with a thick layer of necrosis and slough. VERSAJET enabled us to remove 90% of the devitalised tissue in an outpatient setting thereby alleviating the need for a visit to theatre (figure 3).

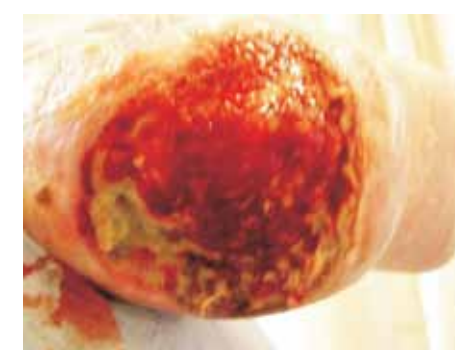
Figure 4 – Post VERSAJET Debridement 29.02.08

VISTA NPWT was applied within 20 minutes of the debridement (figure 4) and the patient was discharged home. Information was given to the district nurses and carers and a clinic appointment was made to review progress. After one week the wound had decreased considerably in size (figure 5). The reduction in size and the associated low levels of exudate (figure 6) facilitated the patient to be changed to conventional therapy after 10 days. The use of combination therapies proved effective despite the risk of recurrent necrosis associated with debriding wounds with limited arterial flow.

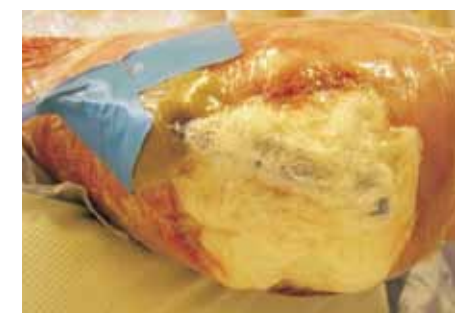
Figure 5 – VISTA NPWT insitu

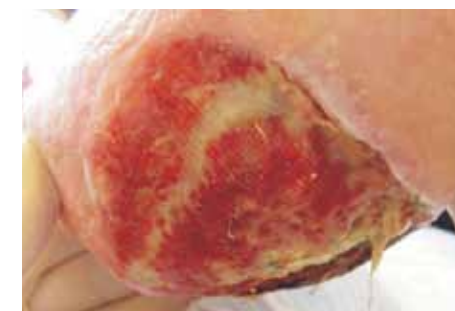
Figure 6 – Wound at first NPWT dressing change 03.03.08
